Manhole Inspection Summary

Manhole # S21A__016MH

Insp Date: **10/18/07 12:07 PM**

Location Address: **721 MONROE ST**

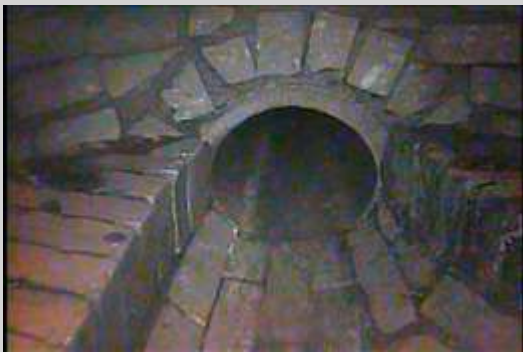
12 O'Clock Outflow

Pipe Height: **8.4** (in.) Rod and Bar (Angled)
Pipe Material: **Clay** ☐ Pipe Lined
Invert Depth: **8.44** (ft.) Flow Characteristics: **Slow**
Deposits: ☒ None ☐ Mud ☐ Sludge ☐ Debris ☐ Grease
Silt Depth: (in.) Deposits Extent:
Infiltration: **None** Pipe Seal Cond: **Sound**

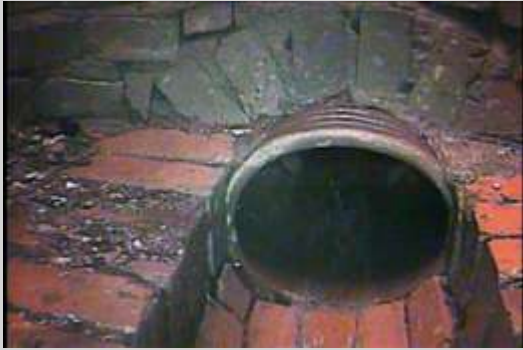
6 O'Clock Inflow

Pipe Height: **8.4** (in.) Rod and Bar (Angled)

Infiltration: **None** Pipe Seal Cond: **Sound**
